Manhole Inspection Summary

Manhole # S19I__019MH

Insp Date: **9/28/07 9:04 AM**

Location Address: **2103 FREDICK AVE**

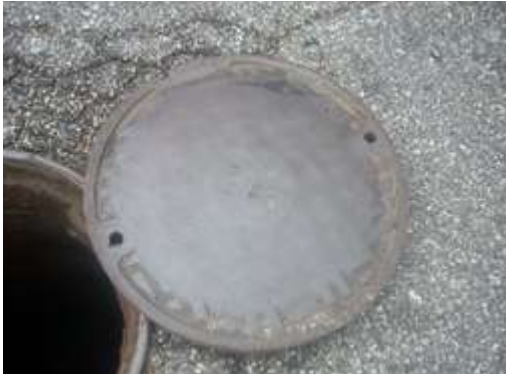
Defect 5

Condition: **Worn**

WORN COVER

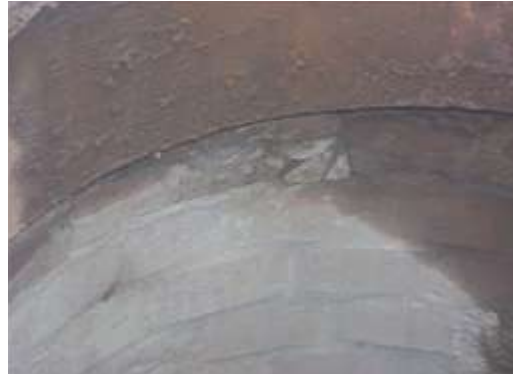
Defect 4

Condition: ☐ Sound ☐ Cracked ☐ Root Intrusion ☐ Loose Brick ☒ **Deteriorated**

CORBEL DETERIORATION

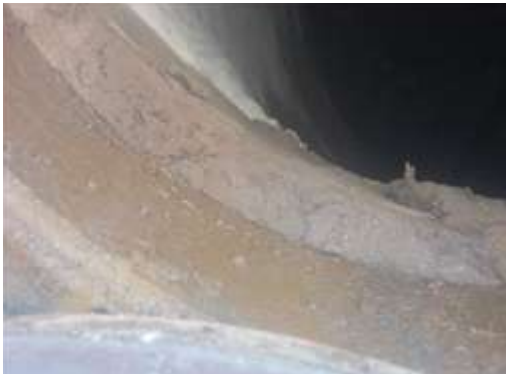
Defect 3

Offset: **1** (in.)

FRAME OFFSET

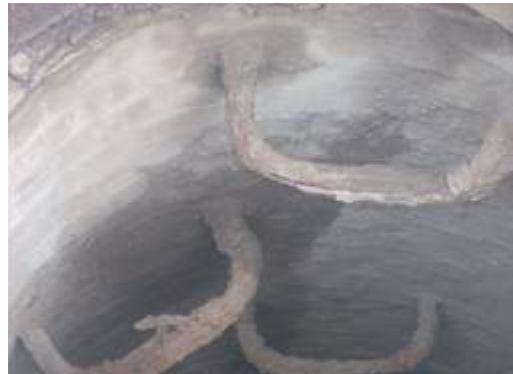
Defect 2

Infiltration: ☐ None ☐ Joint ☐ Cracks ☐ Mortar ☐ Roots ☒ **Wall**

CORBEL INFILTRATION

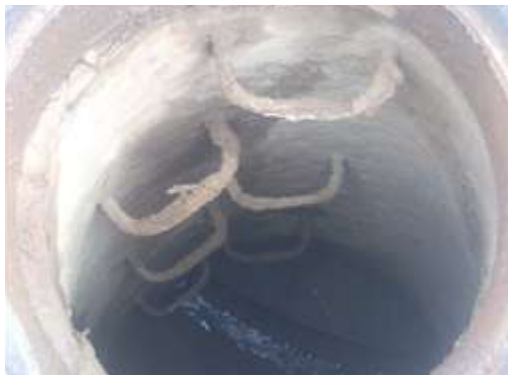
Defect 1

Count: **6** Missing: **0** ☒ **Corroded**

CORRODED STEPS

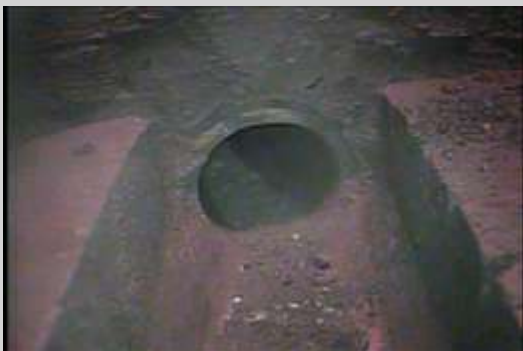
6 O'Clock Inflow

Pipe Height: **7.2** (in.) Rod and Bar (Angled)
Pipe Material: **Clay** ☐ Pipe Lined
Invert Depth: **9.45** (ft.) Flow Characteristics: **None**
Deposits: ☐ None ☒ **Mud** ☐ Sludge ☐ Debris ☐ Grease
Silt Depth: **0.5** (in.) Deposits Extent: **Light**
Infiltration: **None** Pipe Seal Cond: **Sound**
